Lessons learned from recent fires in tall buildings

Fire safety of high-rise buildings

By: Ruud van Herpen MSc. FIFireE

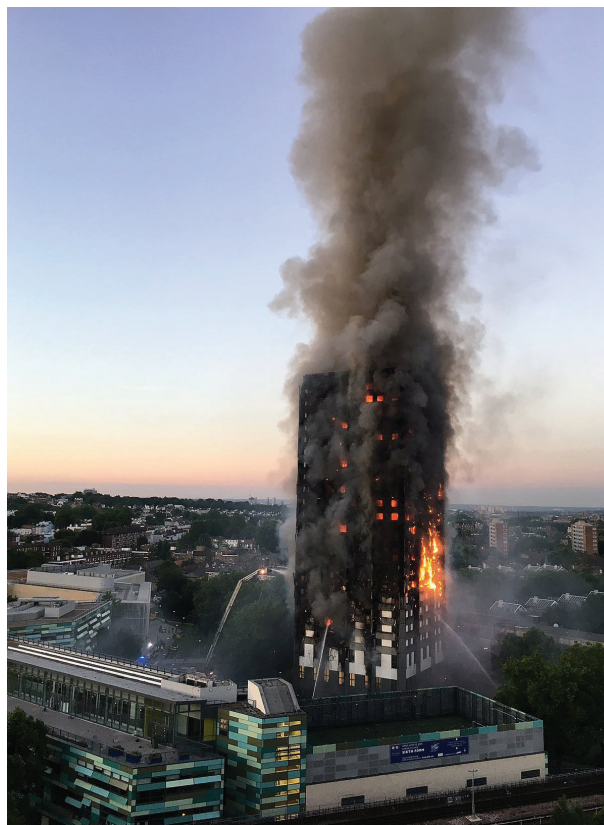
Figure 1: Grenfell tower fire, London

The Grenfell tower is an example of a tall building between 40 and 70 meters. This raises the question whether a fire calamity like Grenfell would be possible in the Netherlands. And yes, of course that is possible. The building legislation in the Netherlands is not better than in the UK, the fire service in the Netherlands is neither, and the same goes for the building occupants. However, there is one important difference between the Netherlands and the UK: in the Netherlands there are not many buildings like the Grenfell tower. The building tradition in the Netherlands differs from the building tradition in the UK. In the 1970s, most new apartment buildings in the Netherlands had external traffic zones and escape routes (galleries) instead of an internal traffic zone. In the Grenfell tower, only one internal staircase was available as escape route. There was no redundancy for safe evacuation, while redundancy very effectively reduces risks.

In the Grenfell tower fire, the fire seemed to spread rapidly on the facade. The facade consisted of aluminium composite material (ACM) cladding with thermoplastic cores. Combustible materials in external dividing structures are acceptable according to the building code, as long as the reaction to fire (euroclass) meets the requirements. However, in the Grenfell case the cladding materials did not meet the euroclass according to the building code and the fire barriers at the story floors failed. The facade fire was able to easily spread to other compartments.

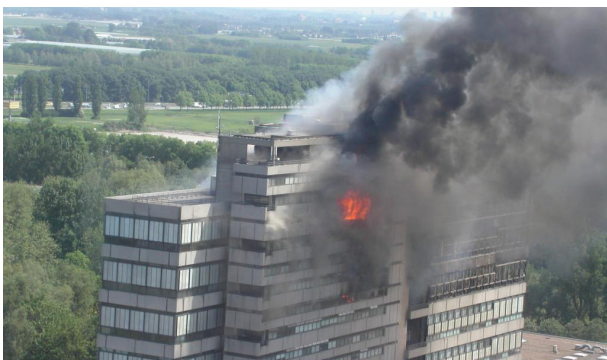
Figure 2: TU Delft department of Building and Architecture on fire: building completely demolished by a travelling compartment fire

The research program already made clear that failure probabilities of fire resistant dividing structures is relatively high, even when they fulfill the requirements of the building code. A burn down scenario of the complete building is possible when there is no efficient support from the fire service. The former department Building and Architecture of Delft University of Technology is a good example of that scenario.

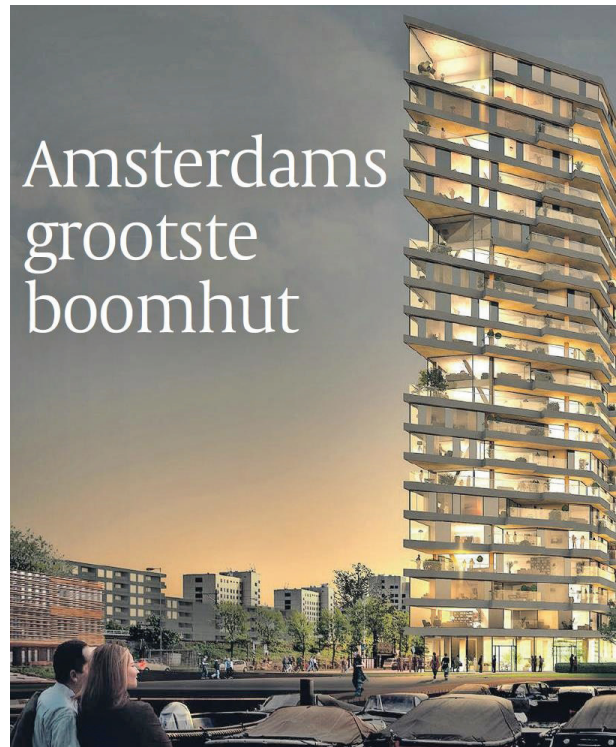
Figure 3: Residential tower 'Haut' Amsterdam

In Amsterdam, a tall residential building of 23 stories with a wooden load bearing structure will be realized (project 'Haut', Amsterdam, Figure 3). The load bearing structure consists of Cross Laminated Timber. It is possible to create a wooden loadbearing structure that can endure a compartment fire. Of course, it is absolutely necessary to prevent that the compartment fire becomes a traveling compartment fire. The fire compartment dividing structures have to be extremely reliable. In this project, a sprinkler system has been added to increase the reliability of the fire compartmentation.
